Replacement of Kasshabog Lake Dam Logs

October 17, 2013

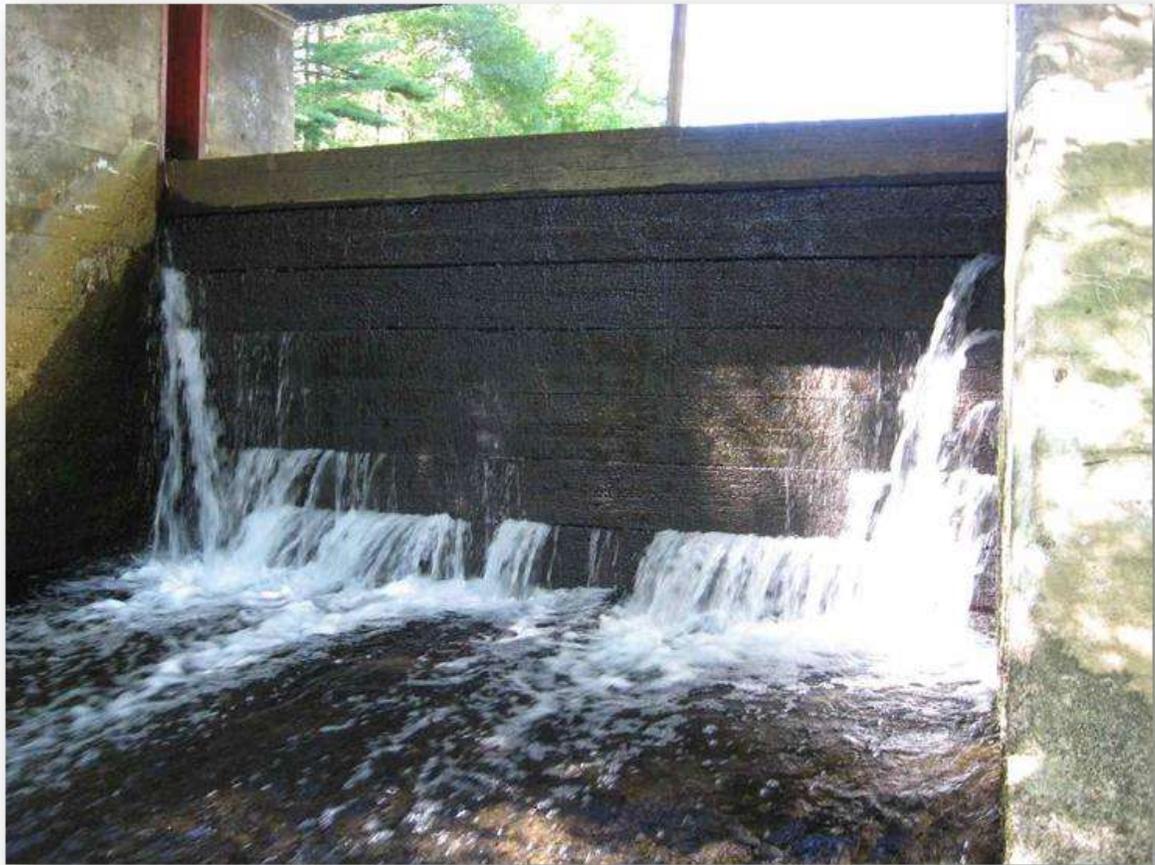
This photo shows the leakage around the old logs. The bottom two are an even older vintage than the ones above. At seven logs deep it is very difficult to remove them all at once, without drawing the lake down and shocking the North River with high flows. Kasshabog Lake is shallow, rocky and has 600 cottages around it so there is lots of interest in what goes on at the dam.

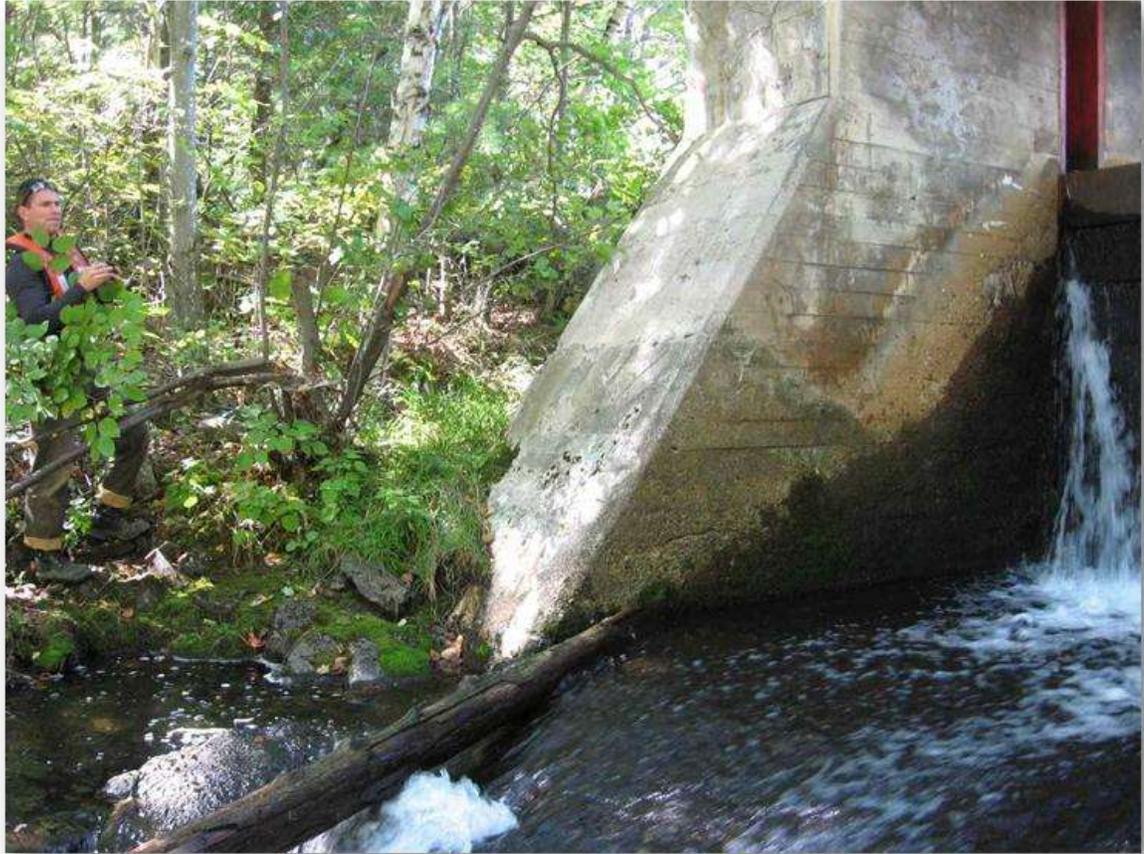
This project called for outside expertise so a request for tenders to replace the stop logs was issued. The RFT stipulated that a cofferdam was to be used with limited leakage. The camouflaged contractor in this site meeting photo was successful with his bid.

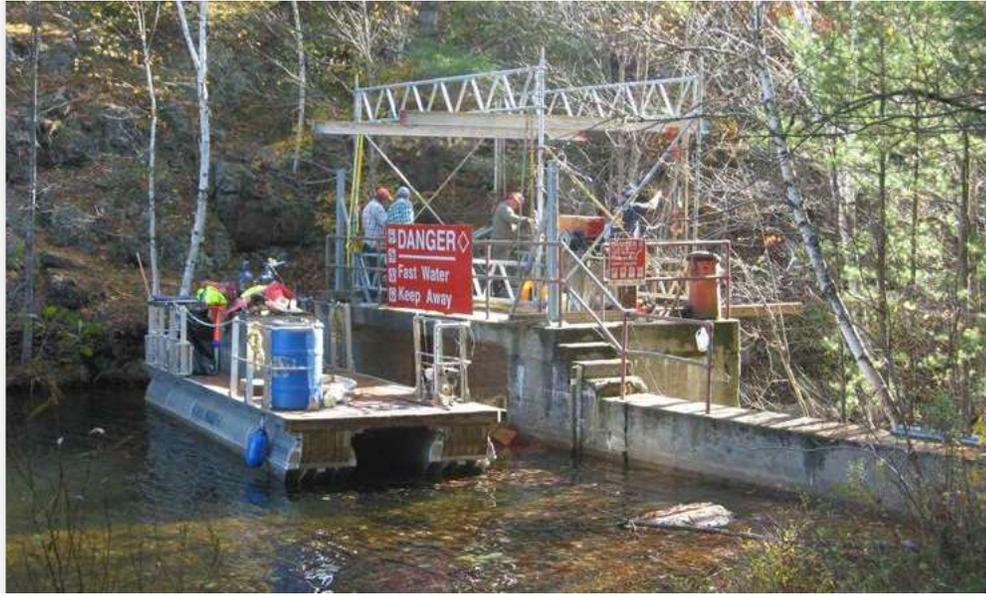
The contractor devised a scheme to place logs on the downstream side of the dam to temporarily block the flow. Without drive-up access, all materials were brought in by boat from a nearby marina. The 5 metre long fir logs do float but out of the water they weigh 200 kg each.

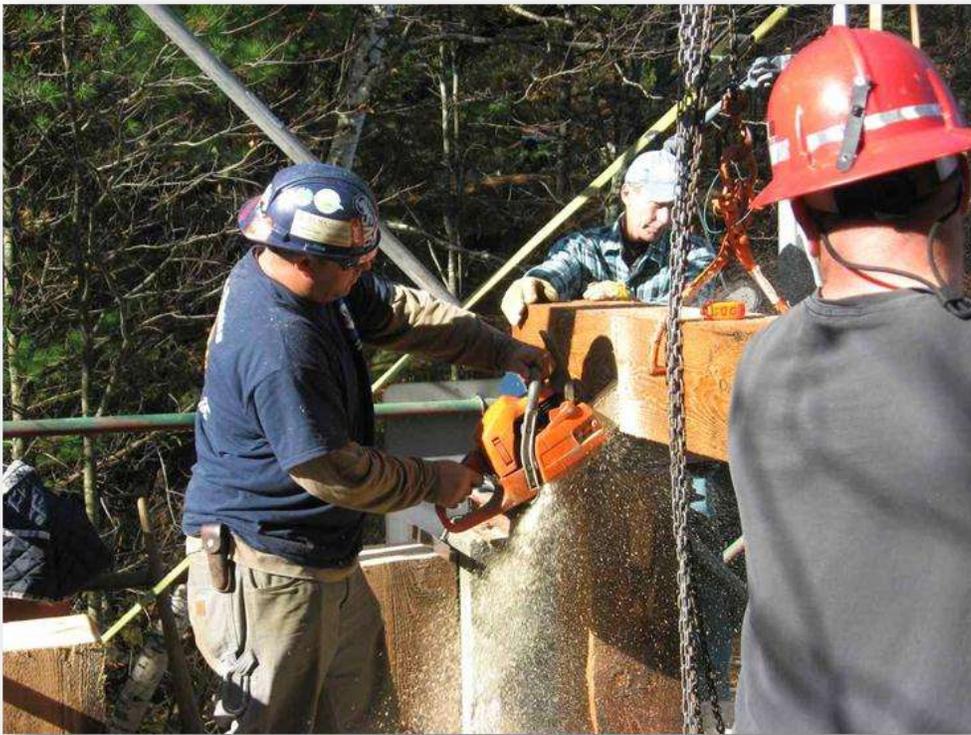
The temporary overhead gantry cranes were used to hoist the logs up from the water, move them from one side of the dam to the other and into position. Below, the temporary logs are being cut to the correct length to fit into the service gains, before being lowered into position.

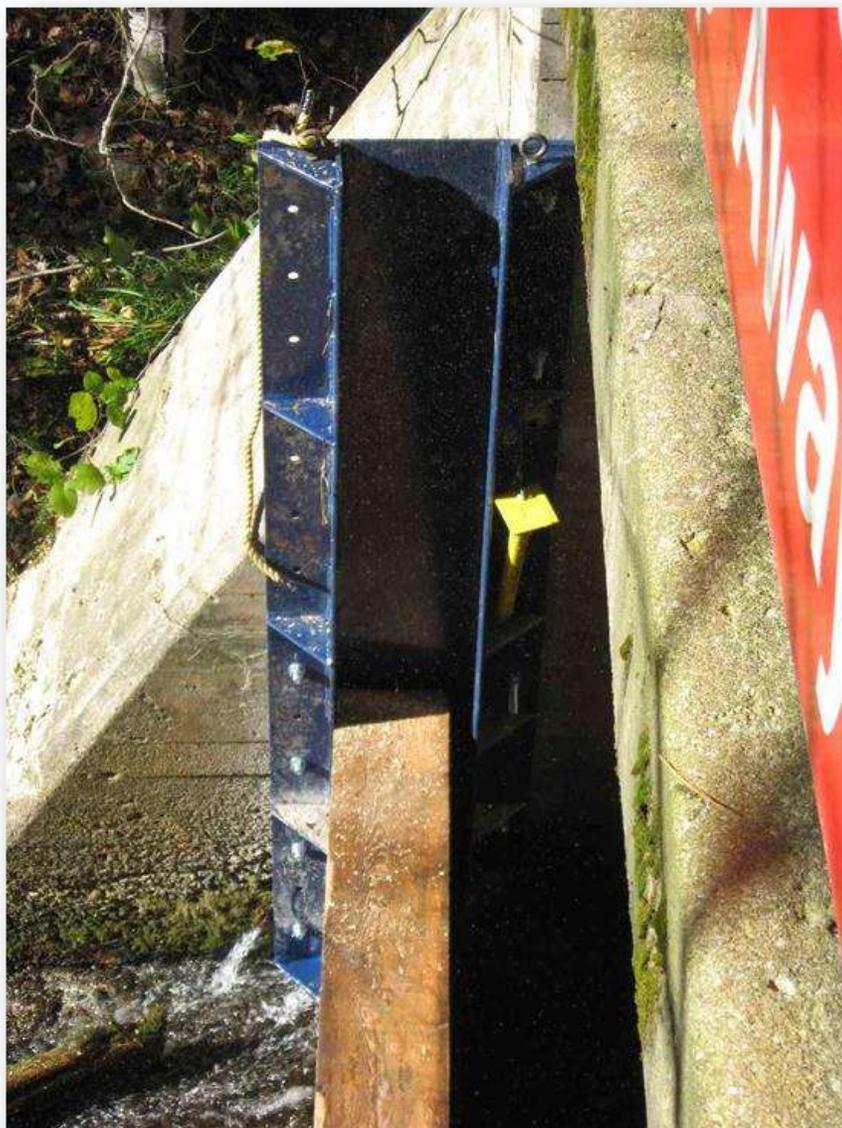
The contractor custom manufactured these blue service gains and attached them to the downstream side of the dam. They hold the logs in place that hold back the water while the olds logs are being removed and replaced.

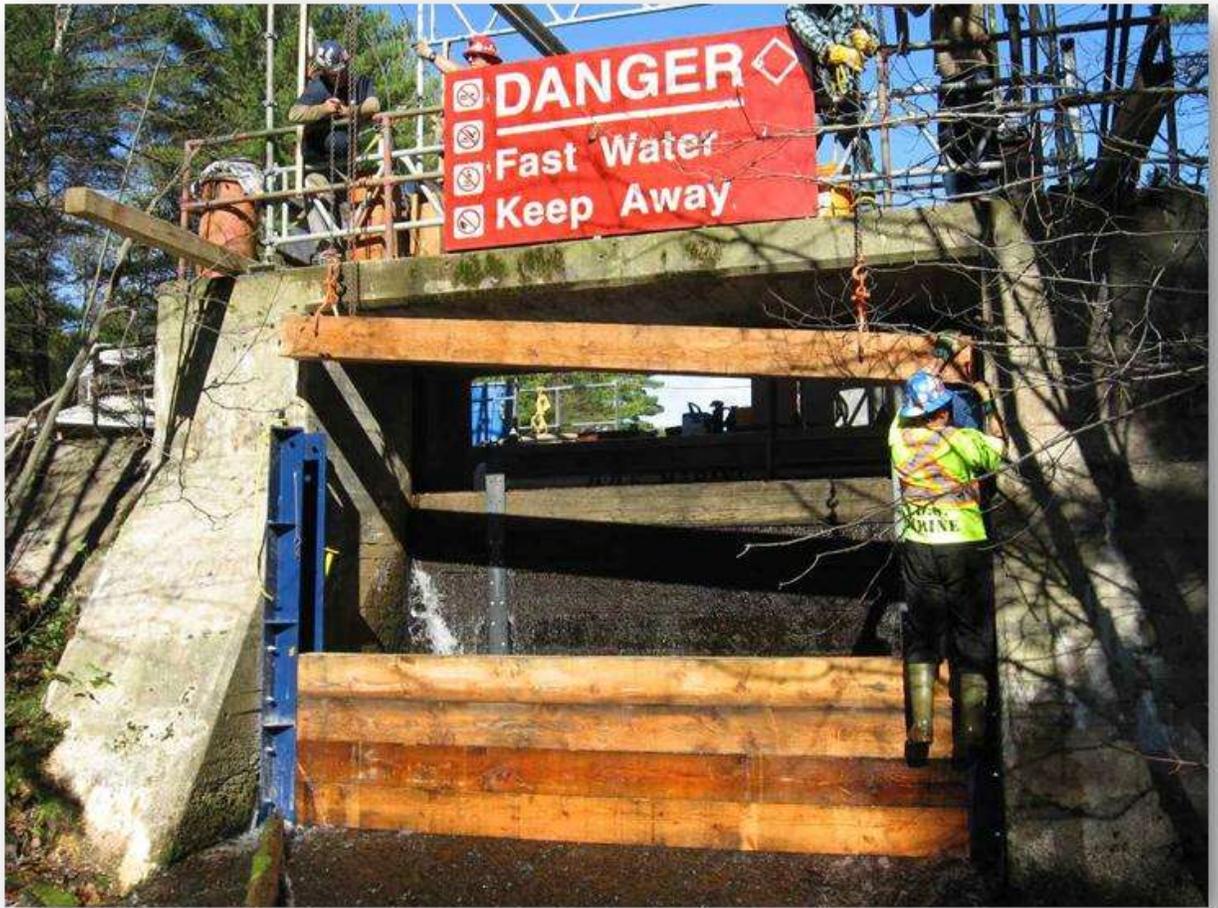
Log being lowered into the service gains:

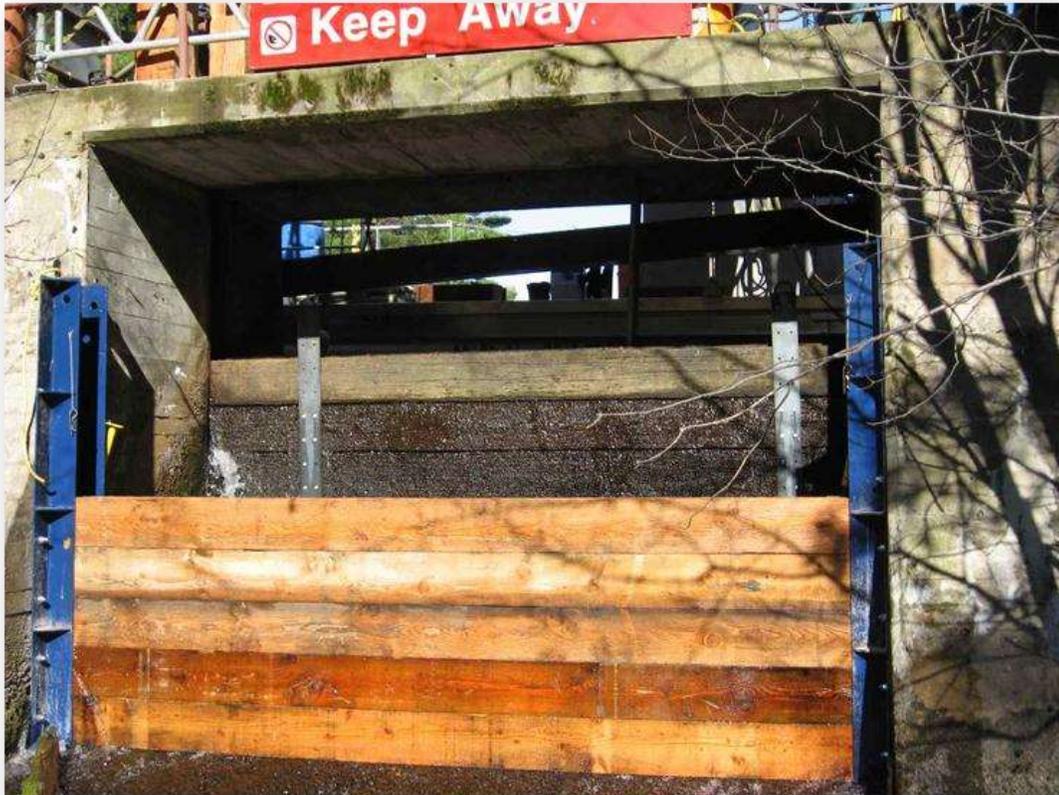
Before this the contractor bolted the old logs together using two flat pieces of steel.

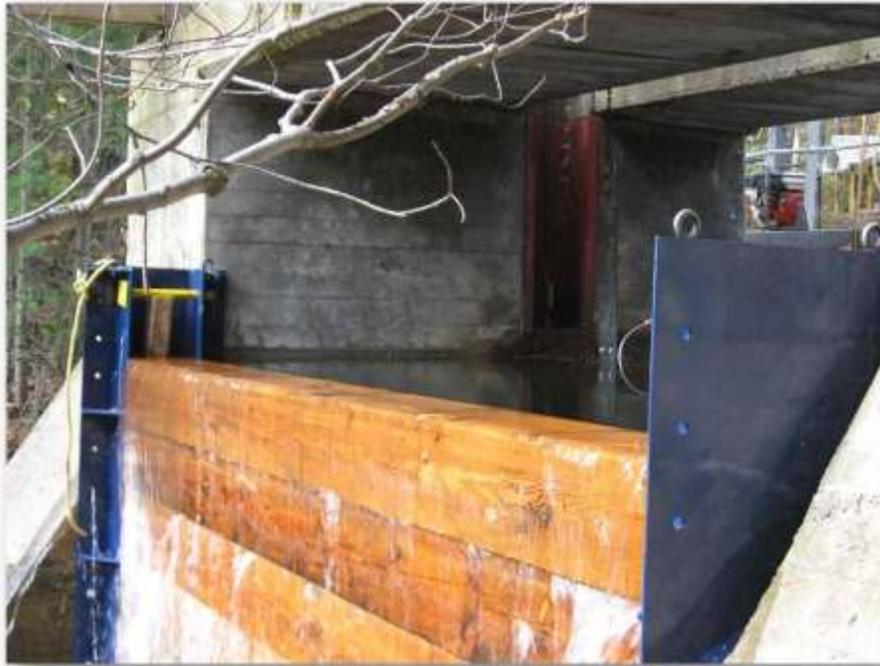
Using the flat pieces of steel on the old logs the contractor lifted them up a little, using a chain hoist. This allowed water to pass underneath the bottom log, flushing out the sill, and filling the space between the two sets of logs with water. The old logs began to float and a diver was used to unbolt them from one another so they could be lifted out separately.

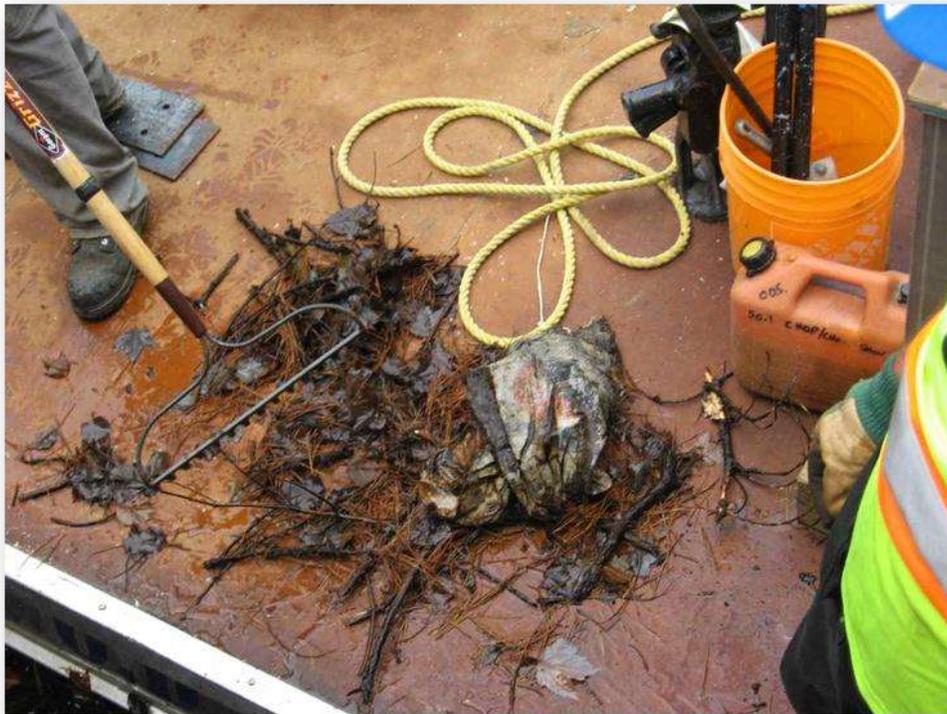
After the old logs were removed some debris in front of the dam was removed to make sure none of it would get stuck underneath the new bottom log or between the new logs. The new logs were then lowered down into place. This picture also shows one of the black jacks, beside the pail, that was to be used to jack the new logs down, pressing them into place and sealing any gaps between the logs to prevent water leakage.

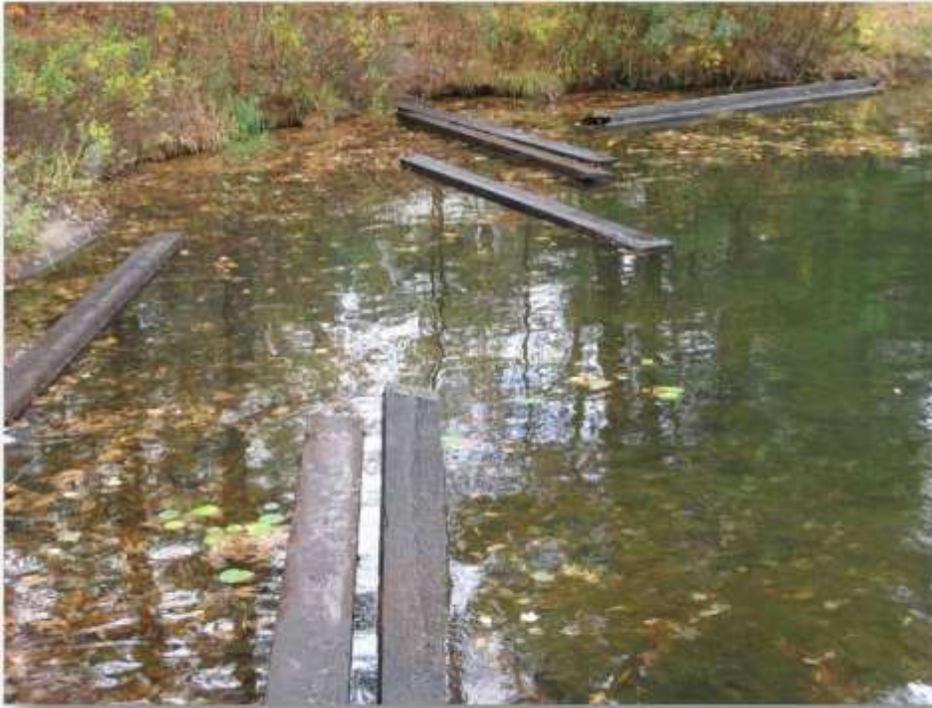
These are the old logs. They will be disposed of off-site.
